Manhole Inspection Summary

Manhole # S59AA_003MH

Insp Date: **3/21/08 9:20 AM**

Location Address: **E MONUMENT ST**

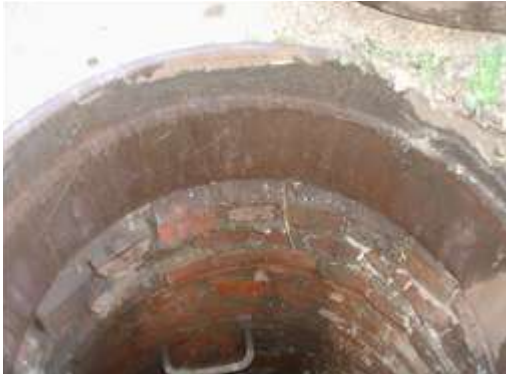
Defect 1

Frame Offset: **0** (in.) Condition: ☐ Sound ☐ Cracked ☒ **Leaks**

FRAME LEAKS

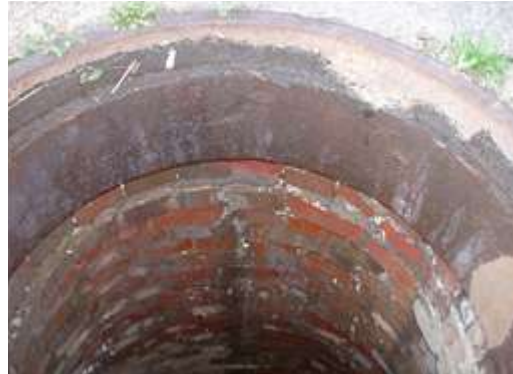
Defect 2

Infiltration: ☐ None ☐ Joint ☐ Cracks ☐ Mortar ☐ Roots ☒ **Wall**

WALL

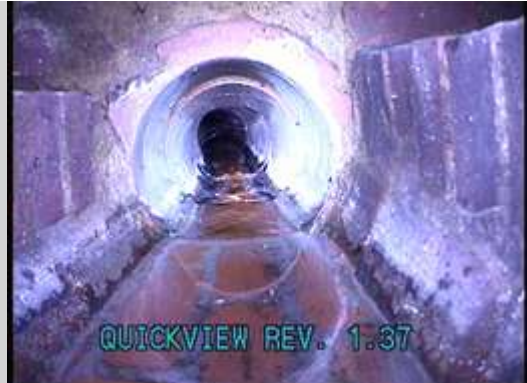
12 O'Clock Outflow

8 in. Circular Gravity Sewer
Pipe Out @ 12 O'Clock

Pipe Height: **8.4** (in.) Rod and Bar (Angled)
Pipe Material: **Clay** ☐ Pipe Lined
Invert Depth: **8.45** (ft.) Flow Characteristics: **Slow**
Deposits: ☒ None ☐ Mud ☐ Sludge ☐ Debris ☐ Grease
Silt Depth: (in.) Deposits Extent:
Infiltration: **None** Pipe Seal Cond: **Sound**

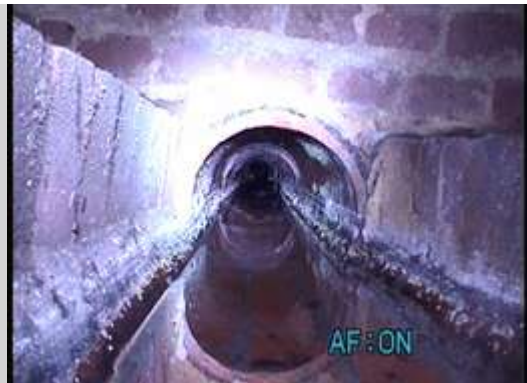
6 O'Clock Inflow

8 in. Circular Gravity Sewer
Pipe In @ 6 O'Clock

Pipe Height: **8.4** (in.) Rod and Bar (Angled)
Pipe Material: **Clay** ☐ Pipe Lined
Invert Depth: **8.50** (ft.) Flow Characteristics: **Slow**
Deposits: ☒ None ☐ Mud ☐ Sludge ☐ Debris ☐ Grease
Silt Depth: (in.) Deposits Extent:
Infiltration: **None** Pipe Seal Cond: **Sound**
